## **Confidential Inspection Report Tampa Bay Area**

**FILE #:** SampleReport2. **DATE OF INSPECTION:** January 12, 2016. **TIME OF INSPECTION:** 8:30 AM. **CLIENT NAME:** Mr. and Mrs. Sample report.

**MAIN ENTRY FACES:** South. **ESTIMATED AGE OF STRUCTURE:** 1961 +/- Confirm with county or public records if necessary. **BUILDING TYPE:** 1 family. **CONSTRUCTION TYPE:** Cement block and wood frame.

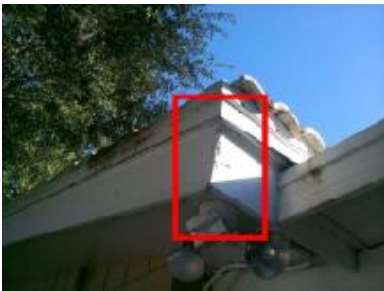
**Damage/rot noted on the fascia @ back of home. Has been caulked but will need maintenance in the near future.**

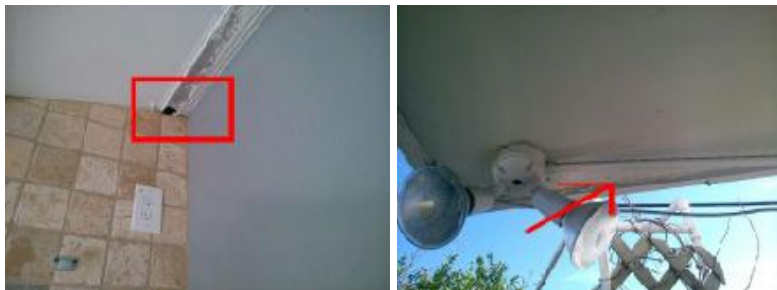
**Soffit screening vents have holes under the eaves in the back behind the exterior wet bar. Recommend the soffit screening is repaired/replaced to keep pests/rodents out of the attic.**

**Stain(s), discoloration/damage noted on the soffit @ front left corner. Recommend a qualified roofer/general contractor/ trade person is called out to make repairs to the soffit.**

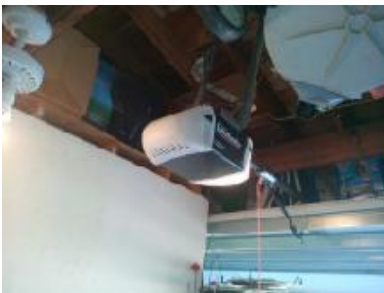
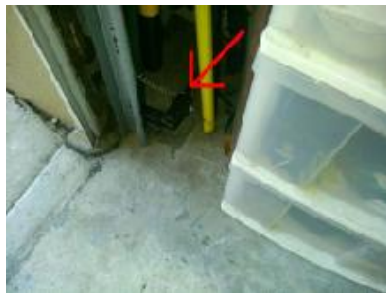
Automatic reverse feature is functioning with the safety beam lights on the bottom of each side of the garage door. **Consider raising the lights 4 to 6 inches from the floor.**

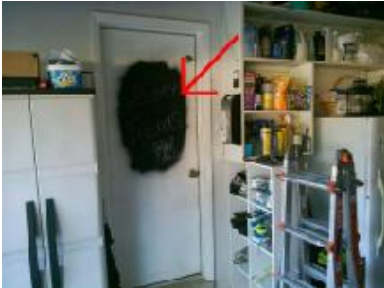
**Entry door from garage to main house has an interior door. Door needs to be an exterior door and fire rated. Recommend having a licensed door contractor make changes.**

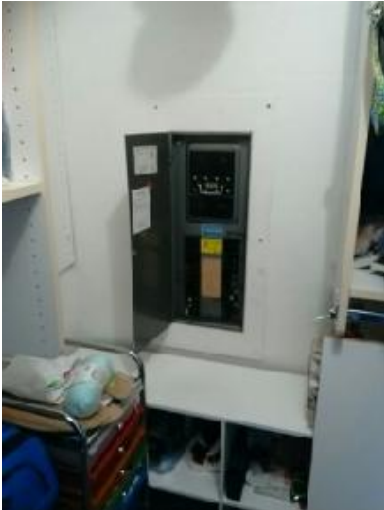
**Electrical panel is located in the bedroom closet and the main breaker is fuses. We recommend consultation with a licensed electrician with regard to upgrading the existing electric service to 200 Main breaker. Insurance carriers may require moving electrical service and / or updating the main fuses and moving to a location other than the bedroom closet. Check with your carrier concerning rates and insurability.**

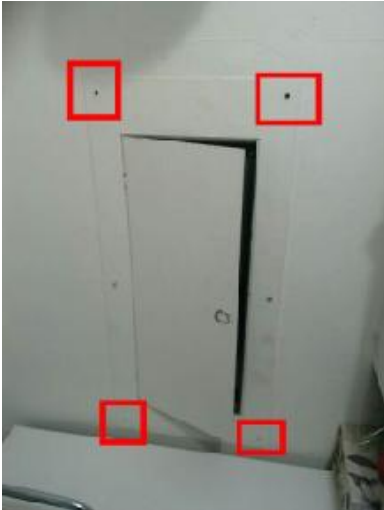
The electrical panel cover is missing cover panel screws. Non-pointed screws need to be installed, this is a safety hazard. Replacement screws are needed and can be purchased at any hardware store.

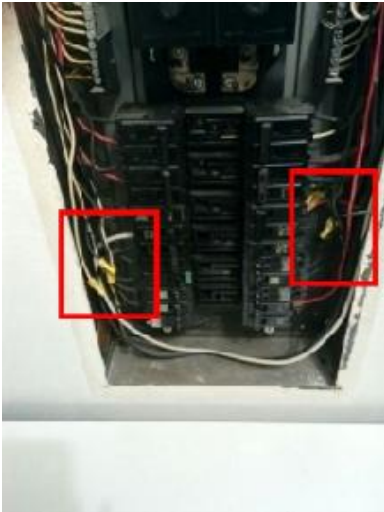
Abandoned or disconnected wiring is found. appears to be from the ceiling radiant heat which in no longer in use. Consider tapping off the wire nuts.

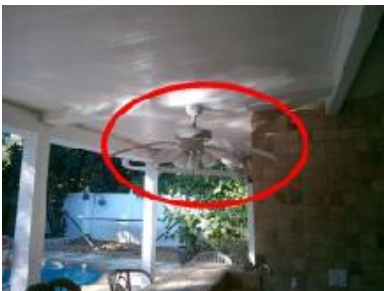
Has an interior fan being used on exterior of the home. Recommend an exterior fan is installed. The fan blades are drooping from being exposed to the elements. Recommend an exterior fan is installed with metal or fiberglass blades.

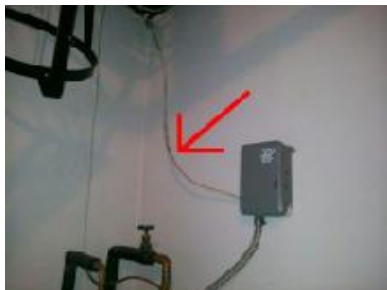
In good condition and functions as intended by manufacturer. Pressure relief valve noted but not tested. A water shutoff valve is installed. Consider flushing the water tank on an annual basis to remove any settlement in the tank as a house maintenance tip. **Exposed electric power wire is subject to damage at the water heater timer. Recommend protective electrical conduit for safety by a qualified person or licensed electrician. (Refer to picture below for viewing exposed wire.)**

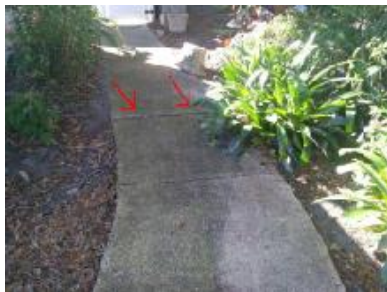
Sidewalks are in good condition. Tripping hazards on the side yard walkway. Repair needed to sidewalk to eliminate any tripping hazard.

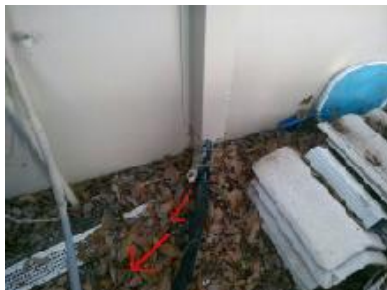
Condensate line is installed and exits by the condenser. Strongly recommend extending condensate line so it drains away from the foundation.

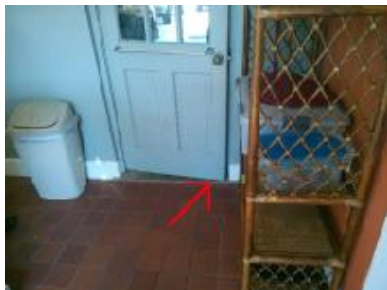
The garage service door(s) rub / sticks. Recommend repairs are made to the door(s) and / or door(s) hardware by a qualified tradesperson to restore easy operation to the door.

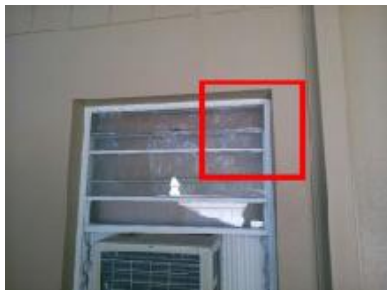
Broken window pane in the garage. Recommend new glass is installed or window is repaired by a qualified tradesperson.

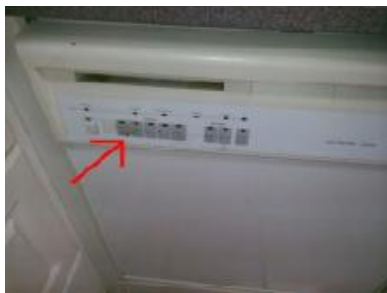
Dishwasher was tested and functional. **Older model appliance. Unit is near the end of its useful life.**

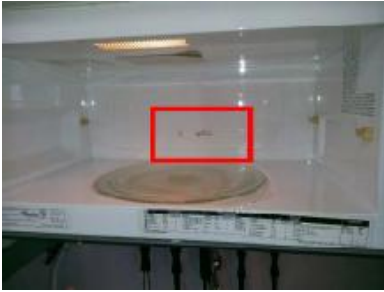
**Burned in the back of the microwave. Recommend replacing.**

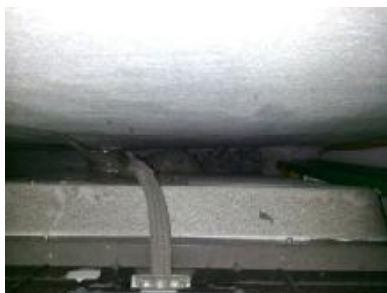
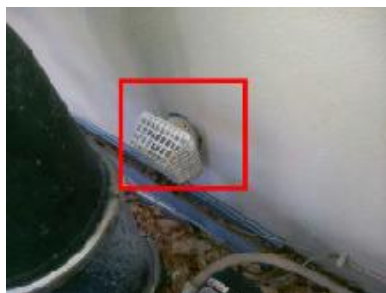
**Recommend sealing around the dryer vent pipe.**

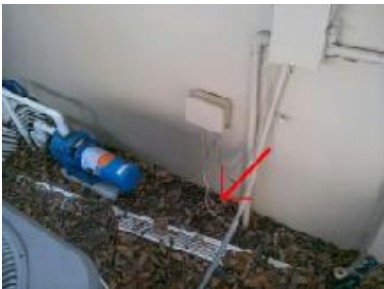
Appears serviceable, **Observed wiring at the well pump which does not have conduit. Covering/conduit is needed on all wiring below the ceiling. Safety hazard !! All wiring needs to be in a conduit to protect the wire(s) from damage.**

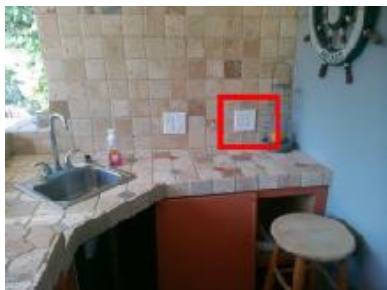
Outlets within 6 feet of the sink are not GFCI protected.
