BUILDING INSPECTIONS SERVICES

RE: Lutz, FL 33549

REPORT SUMMARY

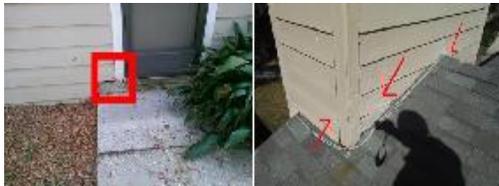
CONDITION: Damaged/rotted from moisture observed on the siding material located on the left side of the home by the side service door of the laundry room, at the back by the pool equipment, the chimney above and below the roof line, and on the right side of the home on the privacy wall. Strongly recommend the deterioration and/or rot be repaired by a qualified/licensed contractor.

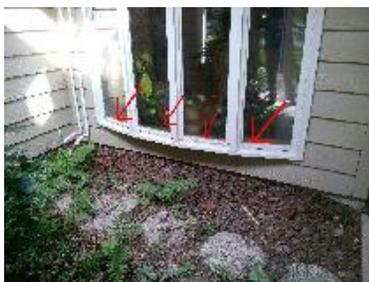
ADDITIONAL COMMENTS: Wood rot on the front bay window frame. Strongly recommend the deterioration and/or rot be repaired by a qualified/licensed contractor.

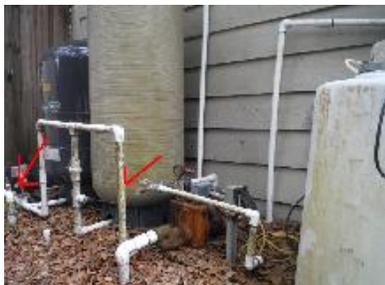
ADDITIONAL COMMENTS: The shallow and deep well are on the same supply line. Recommend further evaluation from a well company as to splitting the water supply so the shallow water does not mix with the deep well water.

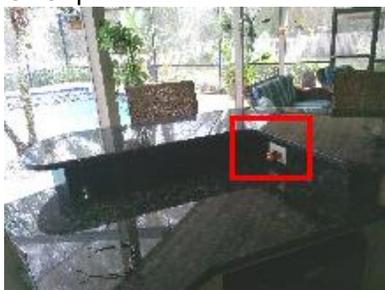
SWITCHES/FIXTURES/OUTLETS: Outlets within 6 feet of the sink and pool are not GFCI protected. Recommend GFCI protection.

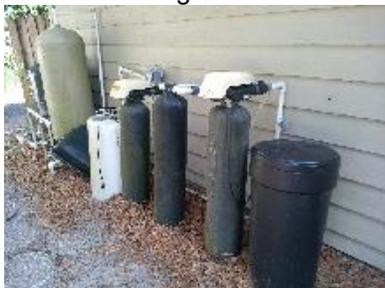
Water softener installed - NOT PART OF THIS INSPECTION. Appears to be in use and functioning as intended. Water softener needs to be calibrated periodically. Recommend contacting a water softener company to come out and check the grains of hardness count on the system.

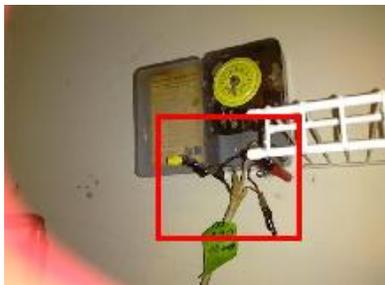
TEMPERATURE SETTINGS: Water heater #2 is 129 degrees. Consider turning down the 2nd water heater to 120 degrees. As a matter of safety, recommend setting the thermostat to 120 +/- if young children are going to be living in the home.

ELECTRIC WATER HEATER CONDITION: Consider flushing the water tank on an annual basis to remove any settlement in the tank as a house maintenance tip.

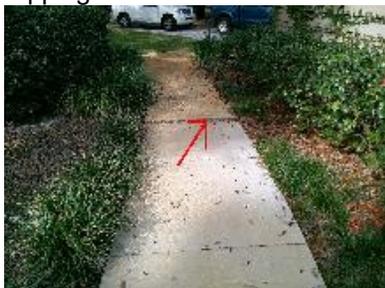
CONDITION: Tripping hazards on the walkway front entry walk way. Repairs needed to sidewalk to eliminate any tripping hazard.

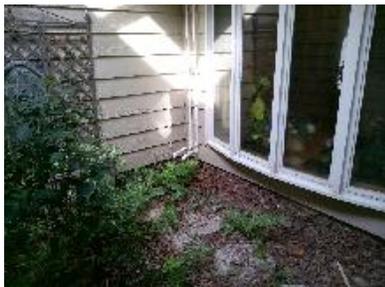
CONDENSATE LINE: Both condensate lines are installed and exit in the front court yard.

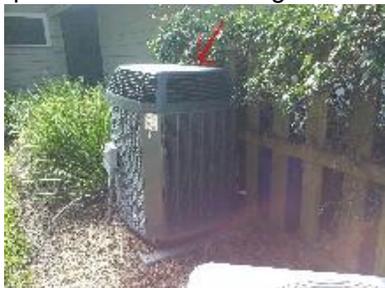
The cabinet is NOT LEVEL. A motor operates more efficiently if it is level. Recommend further evaluation from a qualified air conditioning contractor to make recommendations for repair(s).

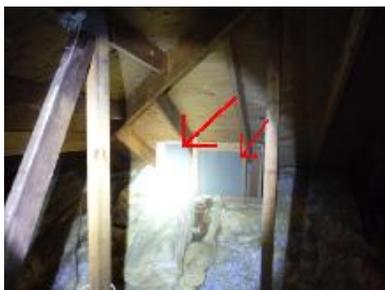
Fiberglass insulation batts have fallen down from the cathedral ceiling side walls in the attic. Recommend the insulation batts are properly secured back in place to ensure full coverage.

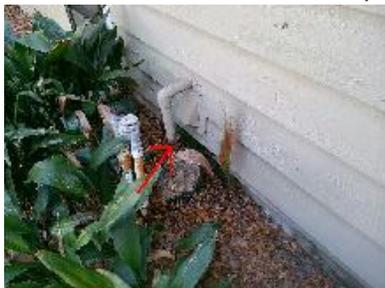
CLOTHES WASHER: Drains to the outside ground. Home has a septic tank and the grey water from the washing machine should drain to the septic tank but in many cases it is preferred to not drain to the septic tank.

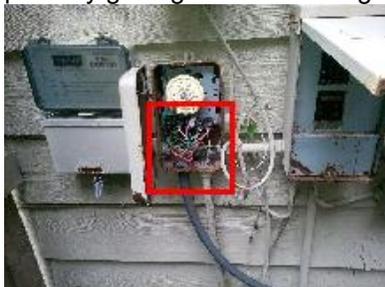
Missing the plastic shield inside the timer box. Strongly recommend a shield is installed to protect the operator from possibly getting shocked during use. **SAFETY HAZARD!**
