## **Confidential Inspection Report Tampa Bay Area**

**FILE #:** SampleReport2. **DATE OF INSPECTION:** January 12, 2016. **TIME OF INSPECTION:** 8:30 AM. **CLIENT NAME:** Mr. and Mrs. Sample report.

**MAIN ENTRY FACES:** South. **ESTIMATED AGE OF STRUCTURE:** 1961 +/- Confirm with county or public records if necessary. **BUILDING TYPE:** 1 family. **CONSTRUCTION TYPE:** Cement block and wood frame.

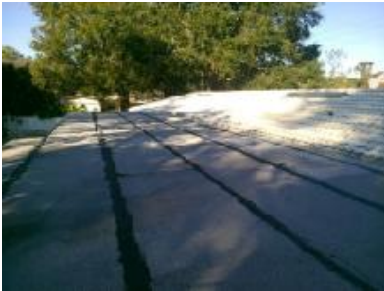
Gable and flat/shed roof.

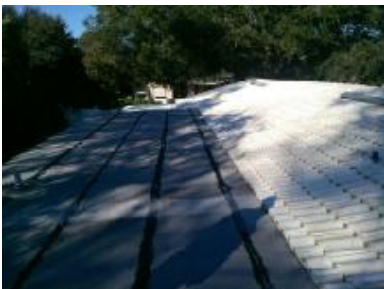
Main roof is a tile system. Flat roof is rolled mineral composition covering over the back area. Metal sheets/standing rib/flat system.

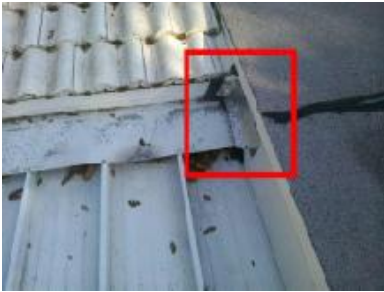
Observed roof flashing being used at the back flat and metal roof. Good condition.

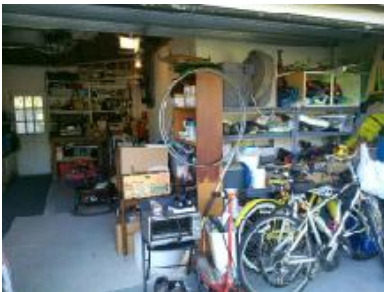
Concrete floor appears serviceable. Floor is not fully visible due to stored items.

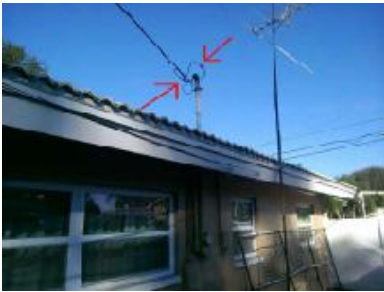
Overhead service with 110 and 220 volt circuit breakers. Monitor the overhead conductors.

**SERVICE DROP CABLE COVERS WILL DETERIORATED OVER TIME :** Service drop cables run between the house and the power pole. These cables are typically maintained by the local power company. **The insulation covers on these cables deteriorates over time, to the point where arcing between cables takes place.** This not only wastes power, but also is a safety and fire hazard. **Notify the local power company to have these cables replaced at no cost to the homeowner.**

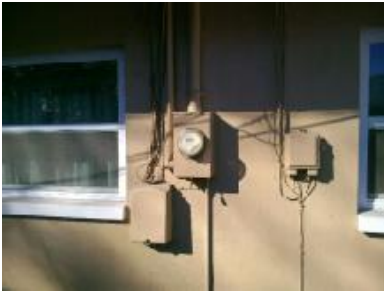
Electrical service is functioning as intended.

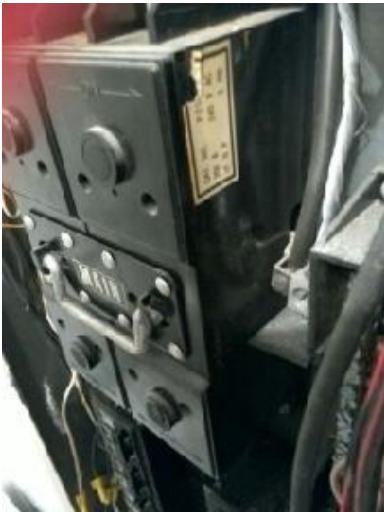
The main panel is functioning as intended.

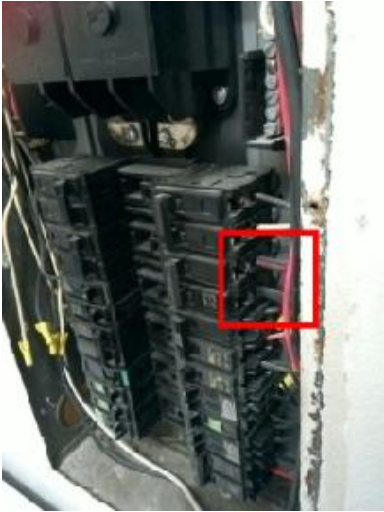
90% +/- copper wiring. 10% +/- aluminum braided wiring.

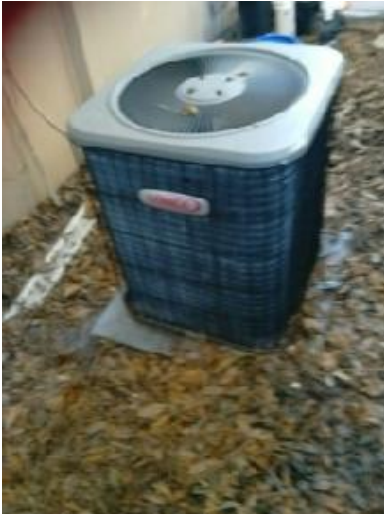
The unit is in good visible condition for its age. The cabinet is level and has platform pad under the unit.

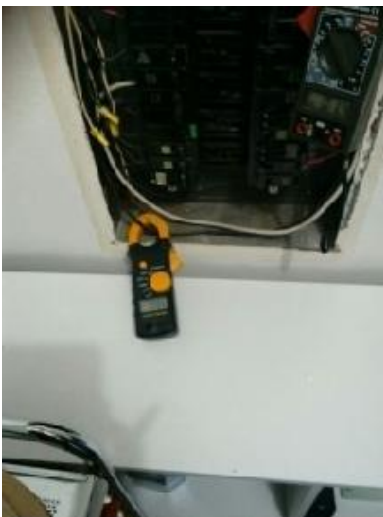
Under load the unit drew: 14.5 amps. When tested, the unit was functioning within the manufactures RLA (rate of load) amperage draw.

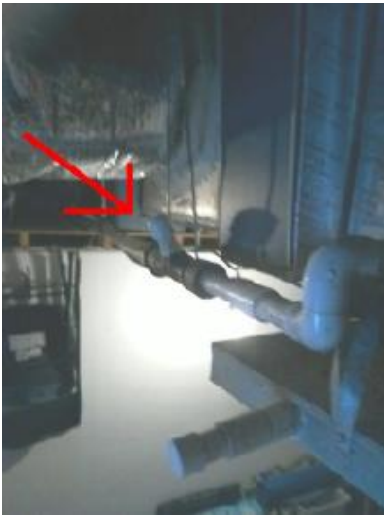
**Condensate line has a T-pipe connection.** This T-connection will allow you access to clean out the condensation line and to pour vinegar through the condensation line periodically which will keep the line clean and free of build up.

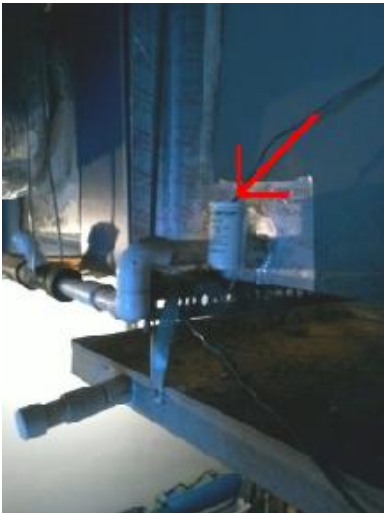
On the PVC overflow line, there is a shut off float switch which appears serviceable.

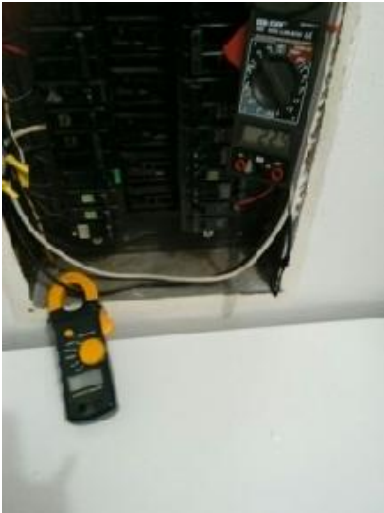
Heat strip(s) under load drew: 22.80 amps. Unit is functioning as intended.

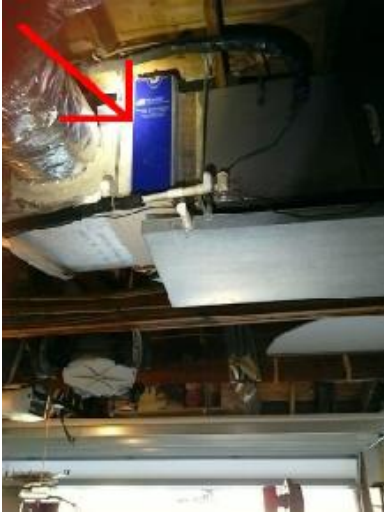
Appear serviceable. Suggest cleaning/changing filter as needed which will help the unit run more efficiently.

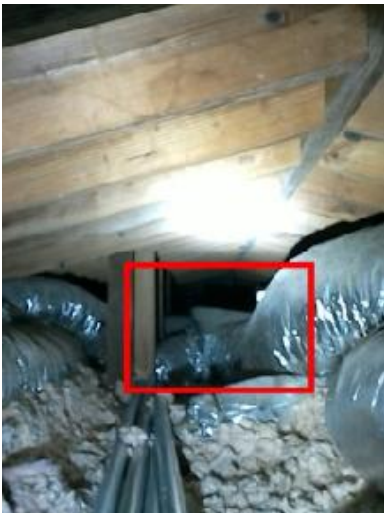
Duct boards appear serviceable.

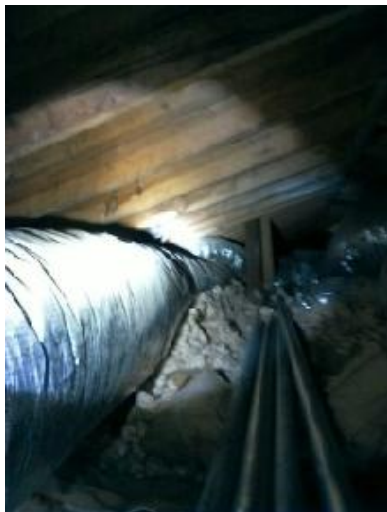
Flex duct appears serviceable.

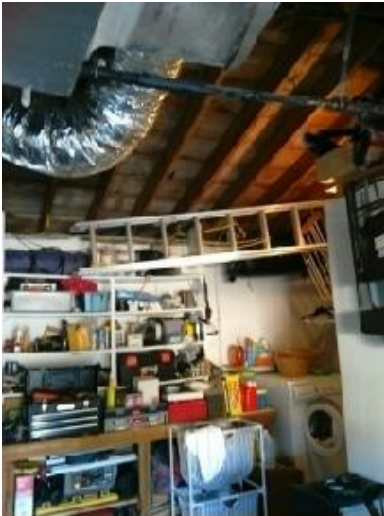
Appears serviceable.

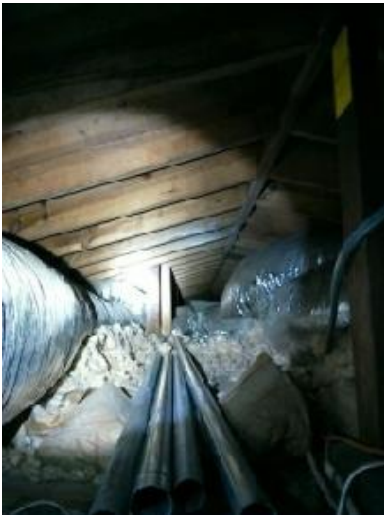
Obstructed view. Low head room. A/C ducts.

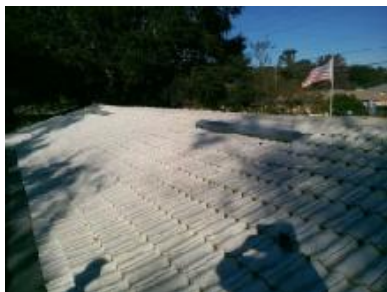
Ventilation is provided by soffit and roof vents. Gable vents are noted on each side of the home.

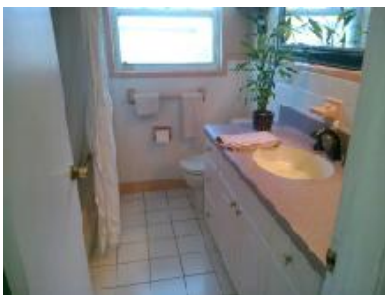
Hall.

Single sink is functioning as intended. Drain appears serviceable. Counters/cabinets appear serviceable.

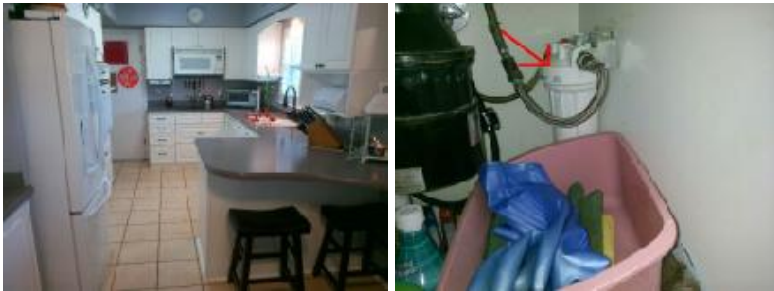
Fiberglass sink, Kitchen sink appears serviceable, Hand sprayer is serviceable, Soap dispenser is installed in the sink and functioning.

**Water filtration system noted underneath the kitchen sink. Recommend changing filters every 3 to 6 months or as recommended by the manufacturer.**

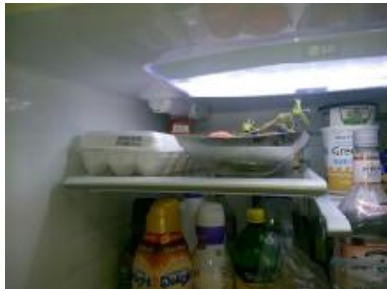
Electric refrigerator. Water and ice dispenser in the door. Ice maker has water filter which will need to be changed as needed depending on how much it is used.

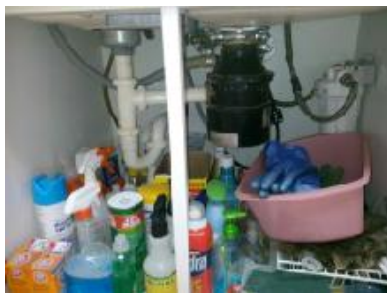
Garbage disposal was tested and is functioning as intended. Wiring appears serviceable.

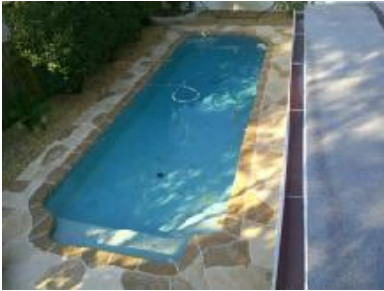
Concrete/Plaster with tile trim.

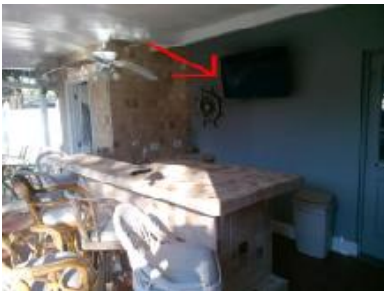
Operable. Light switch is behind the bar TV.

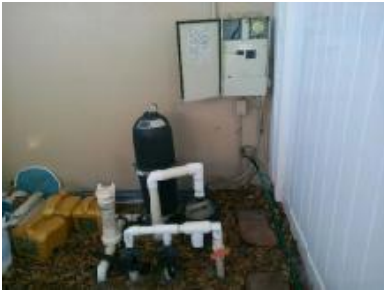
Recommend having the owner explain the pool system to the new owners at the walk through.

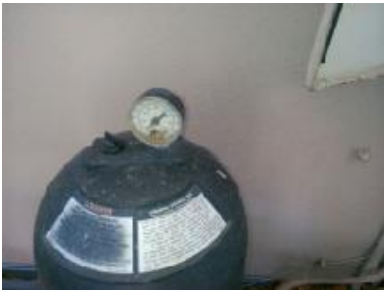
8 psi.

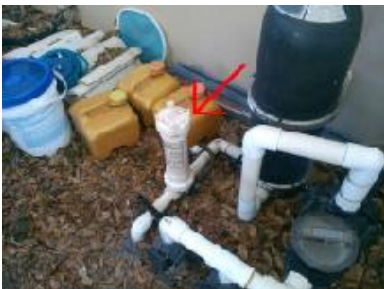
In-line type.

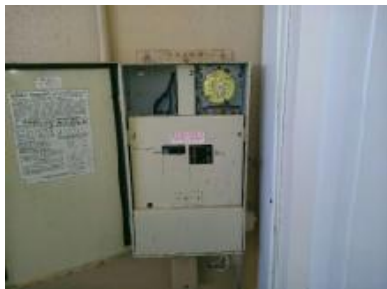
A subpanel is provided OK. Timer is serviceable.

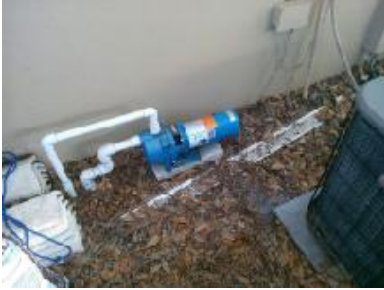
Well.

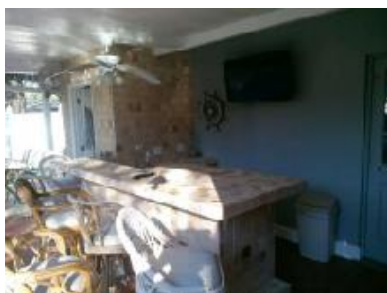
Stainless Steel sink. Appears serviceable.
